NATIONAL REGISTER OF HISTORIC PLACES
REGISTRATION FORM

historic name: **Albert Cofta Farmstead**

other name/site number: **HS-519 (house), HS-520 (well), HS-521 (granary), HS-522 (milk house), HS-523 (barn), HS-524 (garage), HS-525 (hog house), HS-526 (corn crib), Tract # 108-21, Ohio Historic Inventory # SUM 202503**

street & number: **2966 Brush Road**

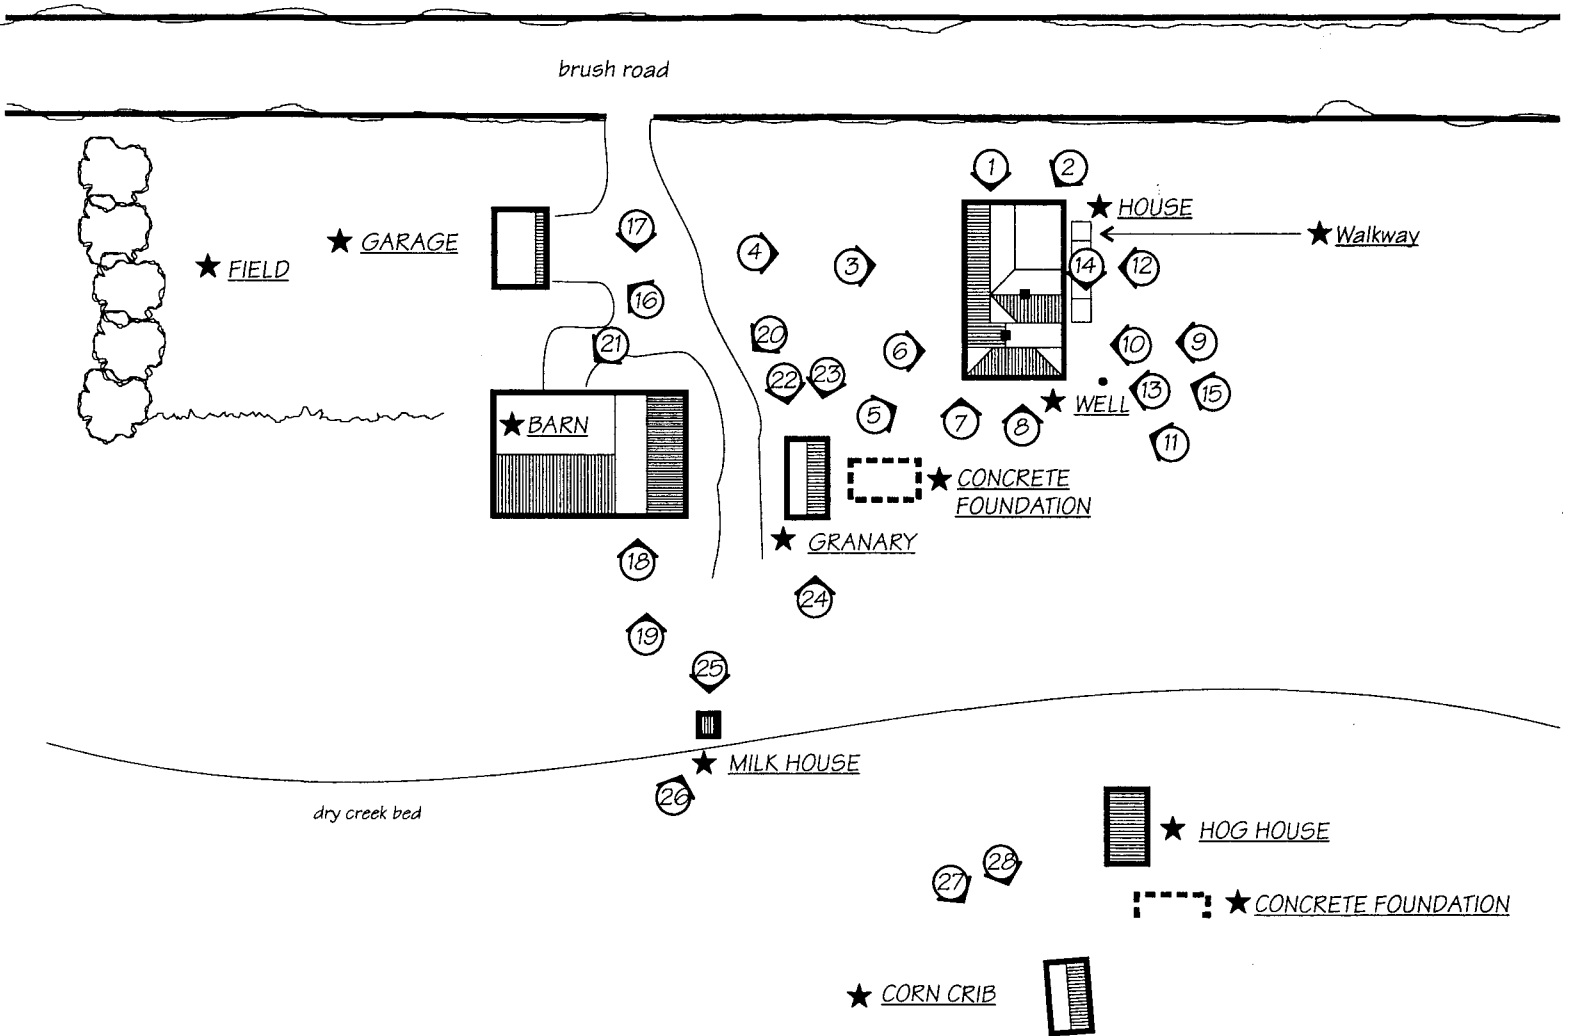
Figure One: Sketch Map

★ CONTRIBUTING RESOURCE

○ PHOTOVIEW

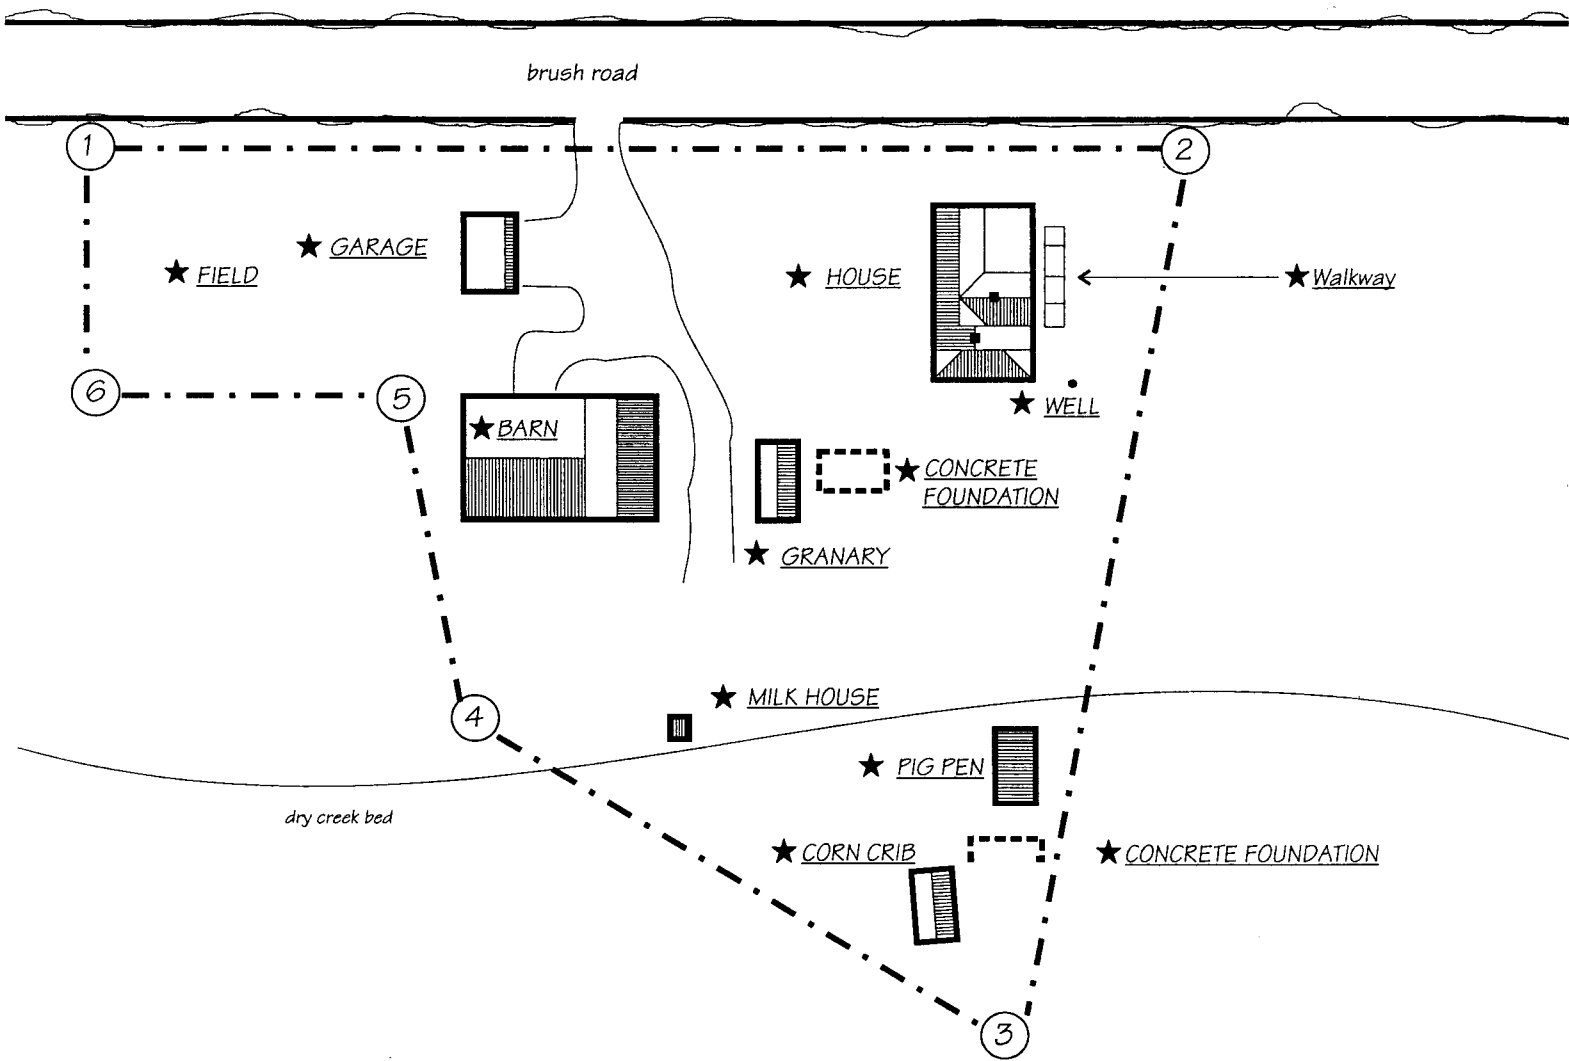
FIGURE TWO
 BOUNDARY MAP
 COFTA FARMSTEAD
 SUMMIT COUNTY, OHIO
 RICHFIELD TOWNSHIP
 JUNE 2003
 CUYAHOGA VALLEY
 NATIONAL PARK

★ CONTRIBUTING RESOURCE

- . - . - . - . BOUNDARY
