NATIONAL REGISTER OF HISTORIC PLACES  
REGISTRATION FORM

historic name: Virginia Kendall State Park Historic District\_\_\_\_\_

other name/site number: Lake Shelter, Octagon Shelter, Ledges Shelter,  
Ritchie Ledges, Property Tracts 119-44, HS-229-45, Happy Days Visitor  
Center, Property Tract 119-53, HS-226,7.

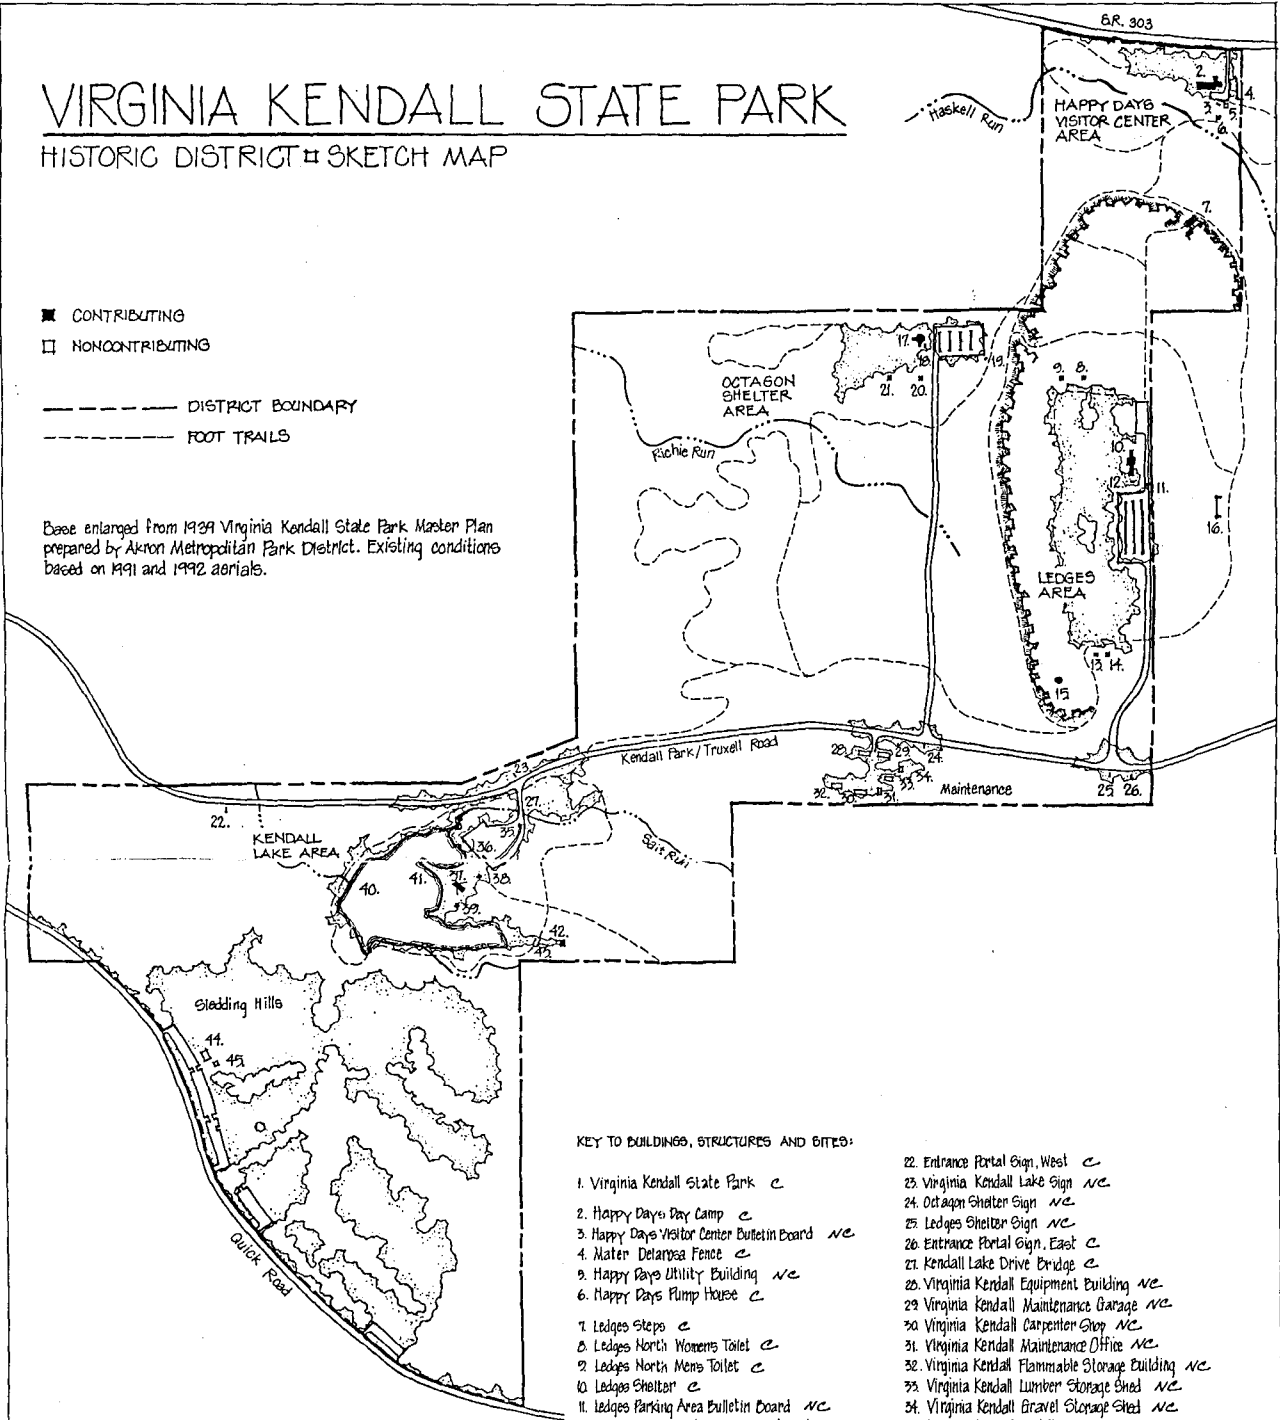
- CONTRIBUTING
- NONCONTRIBUTING
- DISTRICT BOUNDARY
- - - FOOT TRAILS

Base enlarged from 1939 Virginia Kendall State Park Master Plan prepared by Akron Metropolitan Park District. Existing conditions based on 1991 and 1992 aerials.

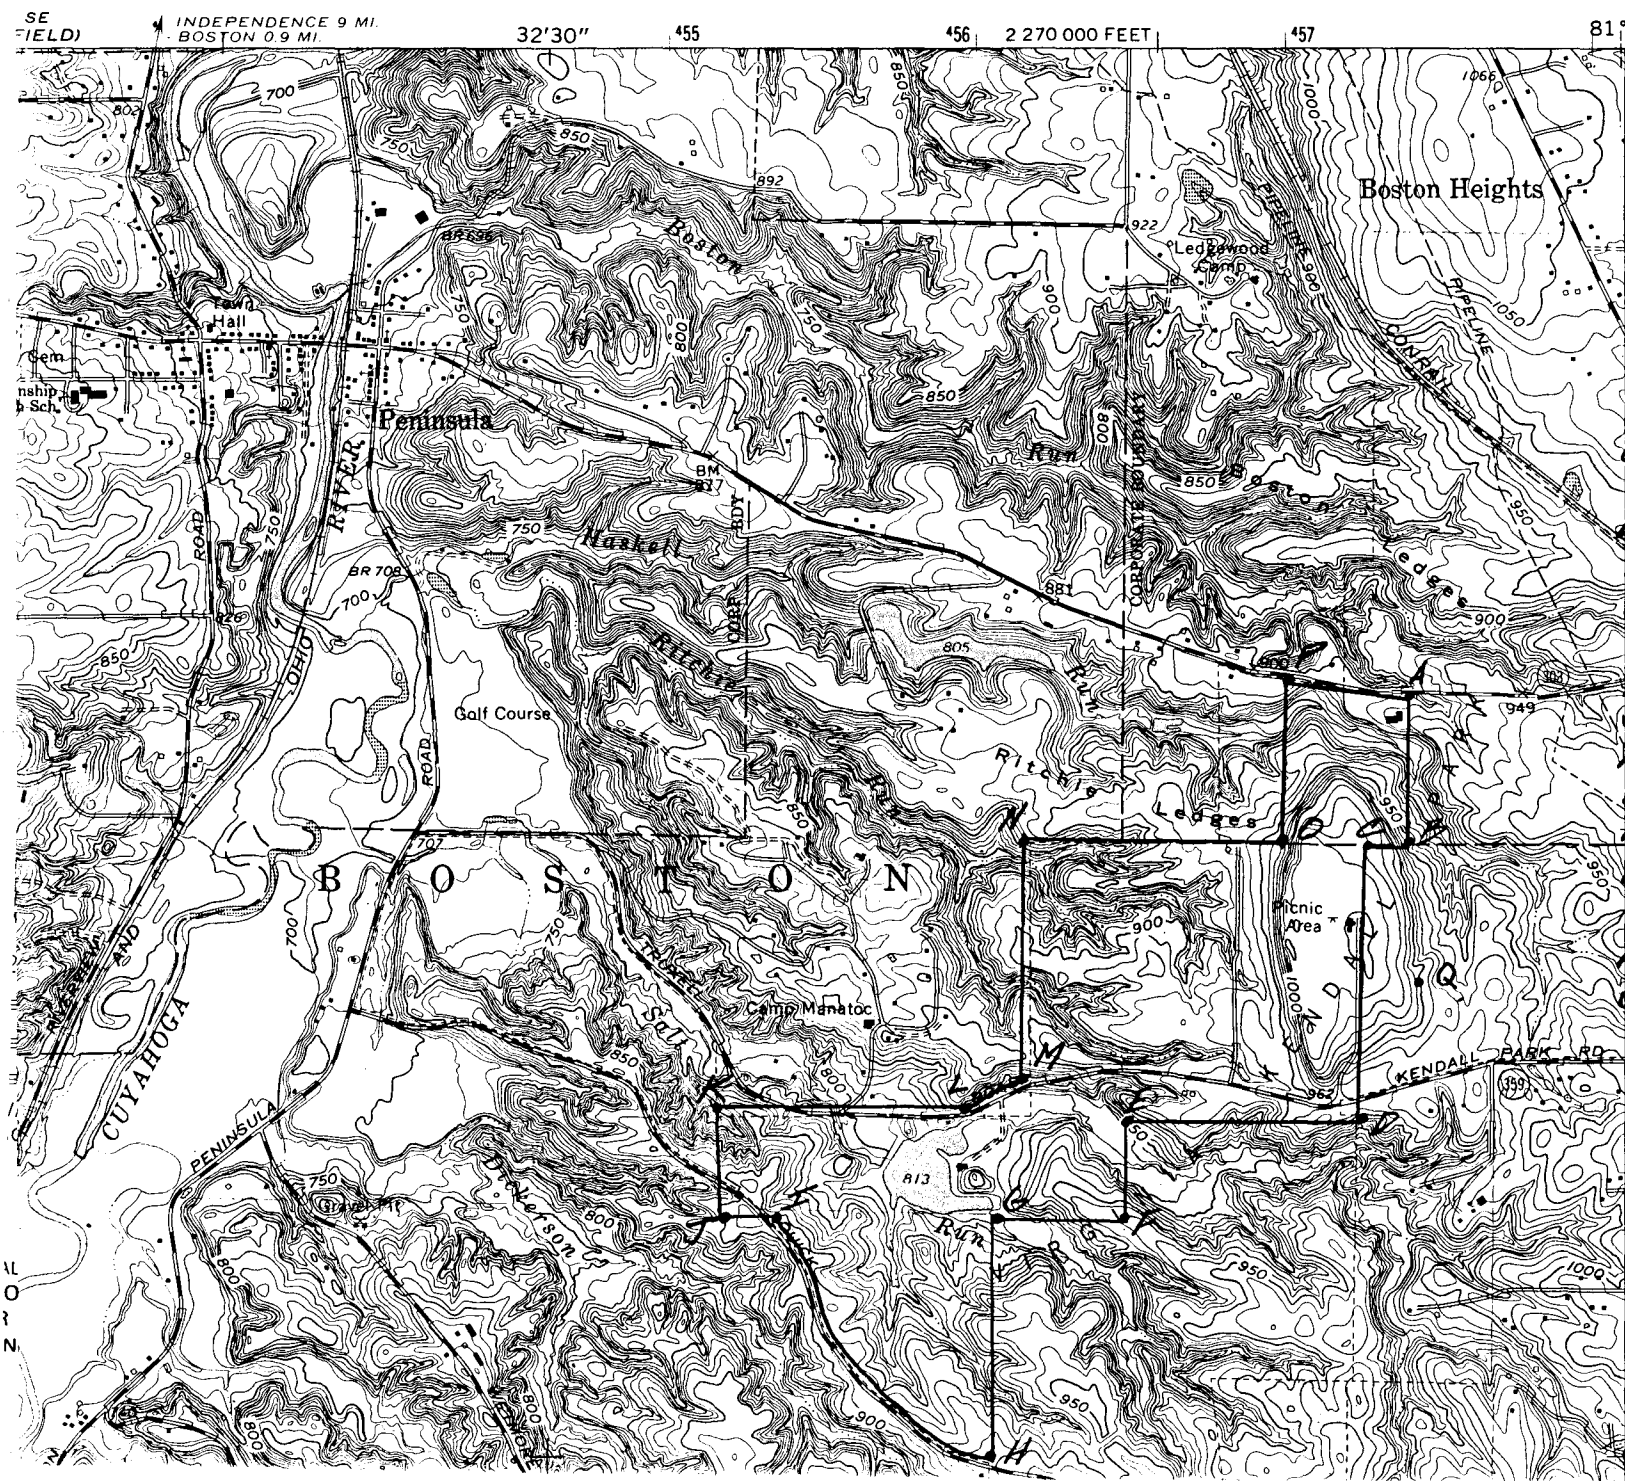
VIRGINIA KENDALL  
STATE PARK  
HISTORIC DISTRICT  
SUMMIT COUNTY,  
OHIO

- Z - E - N
- A: 17-457370-4564330
  - B: 17-457370-4563620
  - C: 17-457210-4563620
  - D: 17-457140-4562910
  - E: 17-456410-4562590
  - F: 17-456410-4562600
  - G: 17-456000-4562000
  - H: 17-456000-4561780
  - I: 17-456280-4562600
  - J: 17-455120-4562600
  - K: 17-455120-4562940
  - L: 17-455900-4562960
  - M: 17-456080-4563000
  - N: 17-456080-4563840
  - O: 17-456960-4563840
  - P: 17-456980-4564400
  - Q: 17-457380-4563340
